Havasupai Reservation Flooding

EXECUTIVE SUMMARY

SUBJECT: Trip Report, Site Visit, Havasu Creek, Supai, Havasupai Indian Reservation, AZ, on 04-05 September 2008.

1. This Memorandum for Record documents the observations of current conditions and damages along portions of Havasu Creek, in the vicinity of Supai, Havasupai Indian Reservation, Arizona, due to a series of afternoon thunderstorms in the upper Havasu Creek drainage basin on Friday through Sunday, 15-17 August 2008. A preliminary assessment is made of potential future concerns and issues that need to be addressed and initial recommendations are made.

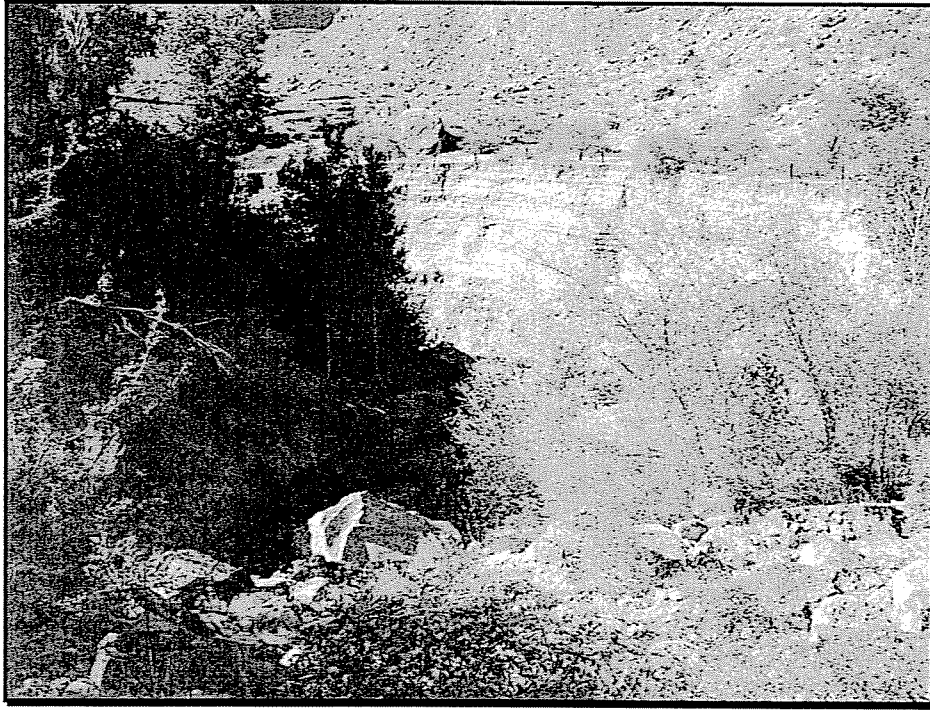
Photo 1. View looking downstream between Fifty Foot and Navajo falls. Cemetery is located to the right and upslope from the large boulder on the far bank.

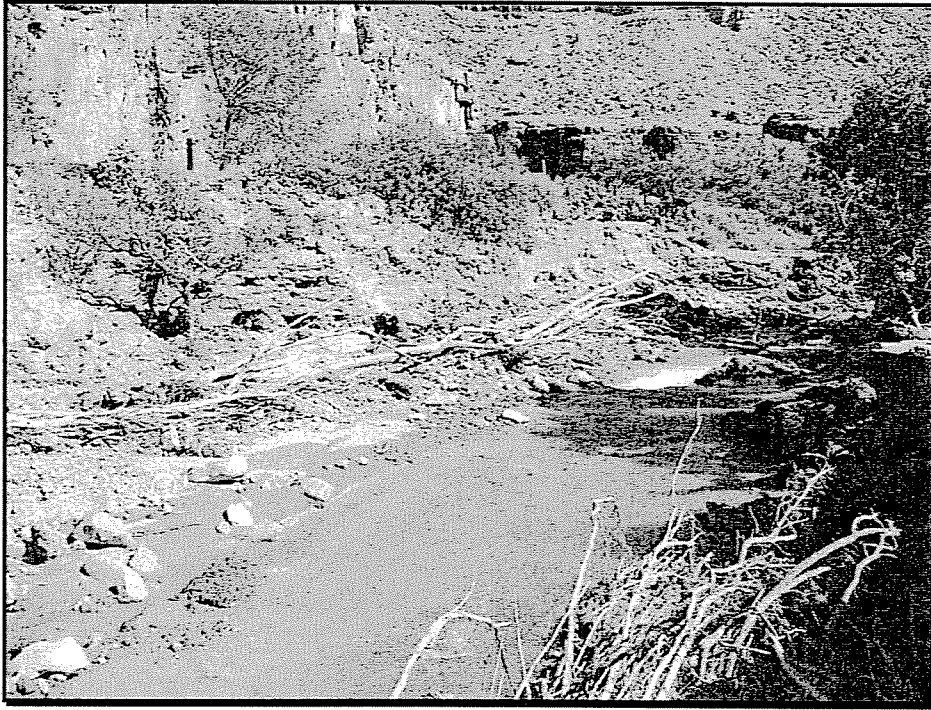
- b. The second cemetery is located downstream approximately 0.25 miles on the west side of Havasu Creek. This cemetery is in immediate danger due to erosion of the creek bank during another heavy flow, especially, since this is the area that had significant deposition of sediments on the east side of the creek, narrowing the creek significantly. See Photo 2. It is suggested that several large boulders currently in the creek be placed near the toe of the slope and smaller stone and gravel be used to fill in the spaces between the boulders. This would be a short term solution. A more permanent solution would require excavation in the creek for sufficient “toe-down” to prevent undermining of the slope protection, a “tie-in” upstream so that the slope protection would not progressively fail in a downstream direction, and a type of slope protection that can withstand the high velocity, high volume flows. Furthermore, an evaluation would need to be made regarding the potential flows to overtop the creek bank in the vicinity of the cemetery.

Photo 2. View of Creek Bank adjacent to the Cemetery downstream of Navajo Falls. Cemetery is located on the far bank behind the fence.

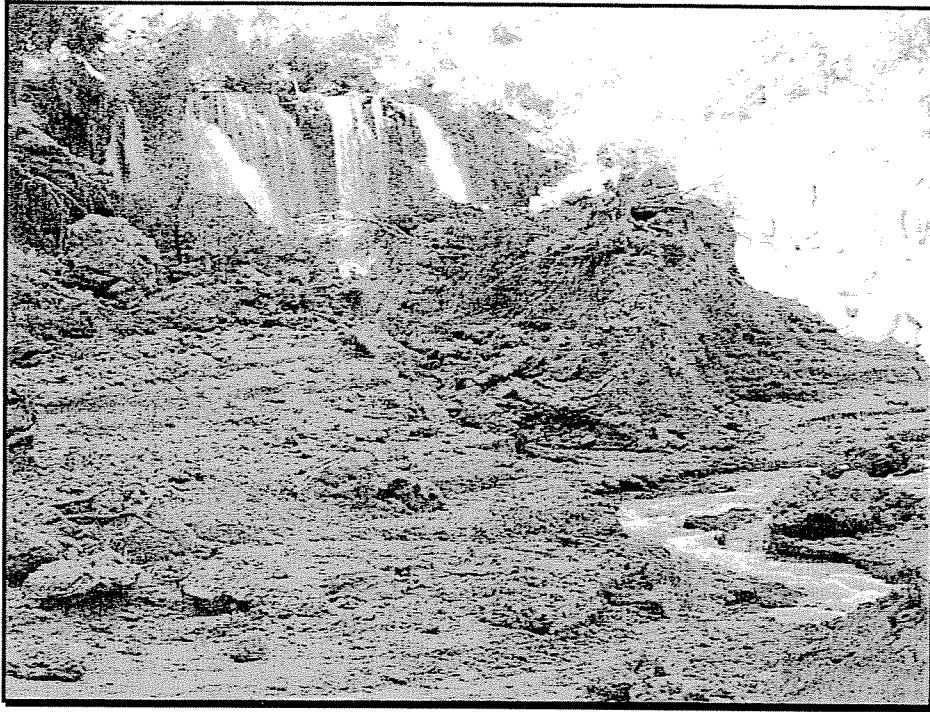
- c. Recommend that the competency of the rock in the vicinity of and upstream from Fifty Foot falls be investigated to determine erosion rates. If the rock between the village and Fifty Foot falls is similar to what was eroded downstream of Fifty Foot falls, erosion toward Supai could proceed at a rapid rate once the erosion resistant rock currently present is removed.

Photo 3. Fifty Foot Falls looking Upstream Over Recently Eroded Area.

- a. A potential long term solution that would address all of the damages and future damages described above is the placement of a detention basin upstream from Supai. The purpose of the basin would be to “knock the peak off” of future flood events, reducing flows to levels that would not cause significant damage. A much more detailed study would be required to select a suitable location, determine storage and discharge capacities, and evaluate if environmental impacts to both Havasu Creek and the Colorado River are acceptable.
- b. A relatively inexpensive measure would be to install one or more telemetry rain gages in the upstream watersheds.
